NRL Report 6293
AFML-TR-64-408

Electron Microscope Fracture Examination to Characterize and Identify Modes of Fracture

C. D. BEACHEM

*Physical Metallurgy Branch
Metallurgy Division*

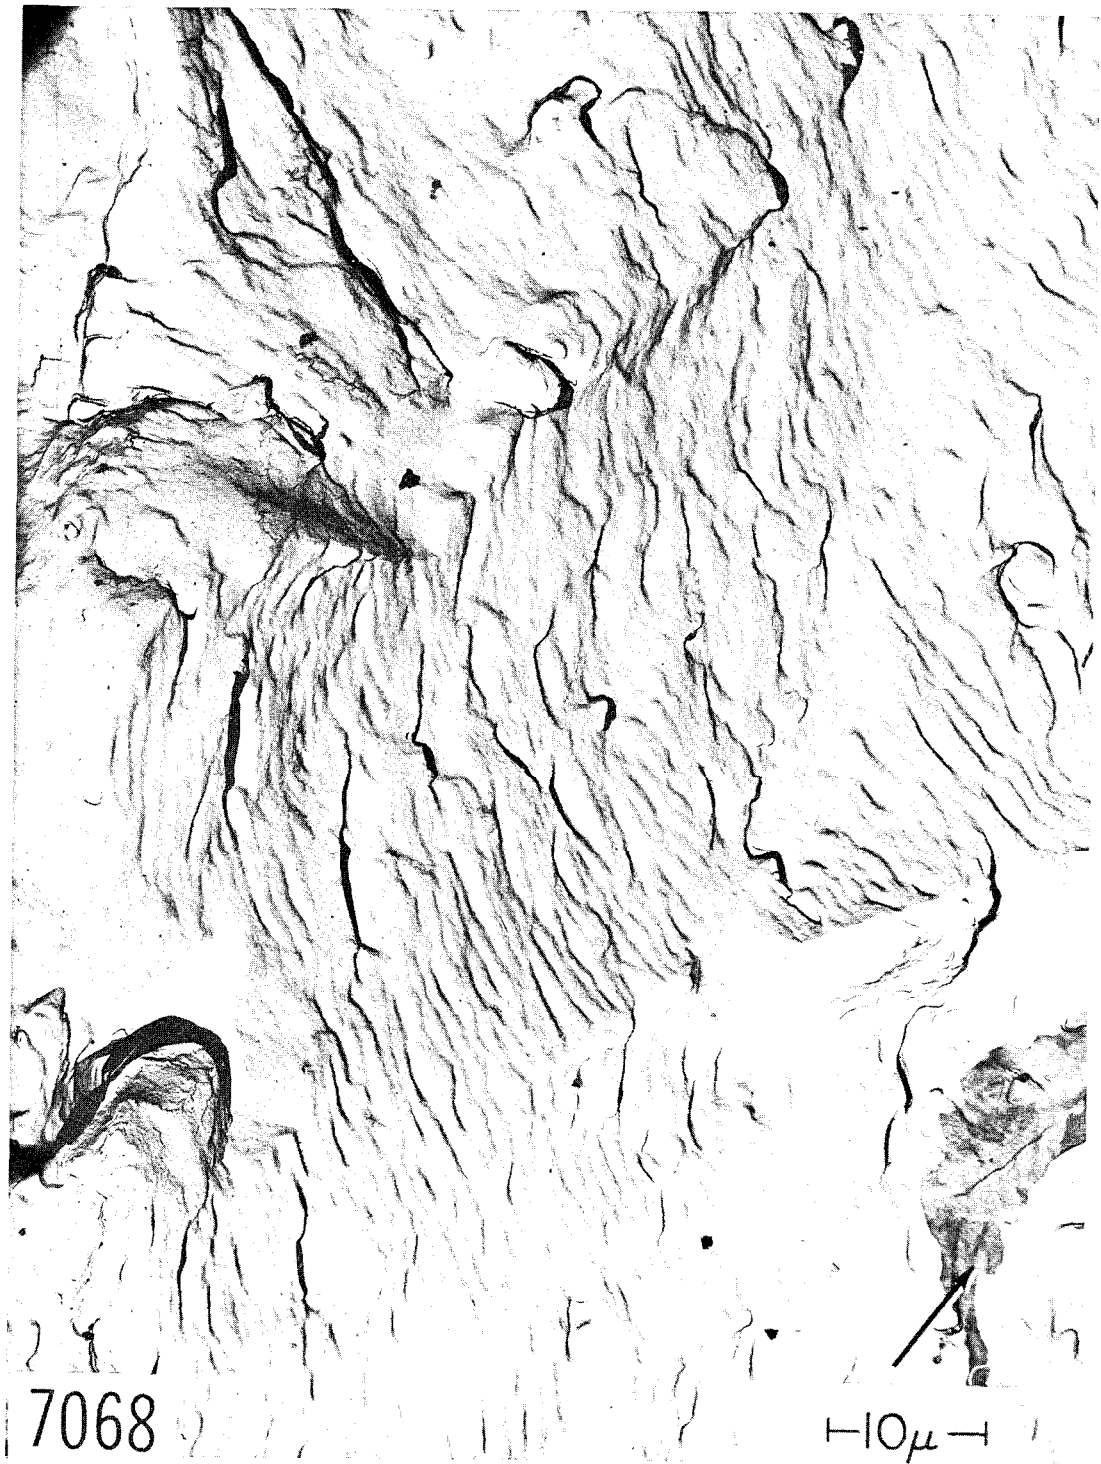
Fig. 85 - Fatigue markings in the WR crack shown in Fig. 82. Cellulose acetate-carbon replication technique. Palladium shadowed. 2500X.

Two center-cracked sheet specimens of Ti-2-1/2Al-16V, both 1 in. wide, 0.062 in. thick, and aged for four hours at 900°F (R_c 41), are shown in Figs. 81 and 82. The fatigue crack in the specimen shown in Fig. 81 was propagated in the RW direction and the crack in Fig. 82 was propagated in the WR direction. Figures 83 and 84 are high magnification fractographs of the RW fatigue crack and Figs. 85 and 86 are fractographs of the WR fatigue crack. The difference between the two modes in this material is quite pronounced - the RW mode exhibits extremely equiaxed features, with few striations. It is not at all certain what the striation-like markings on the WR fracture surface are.

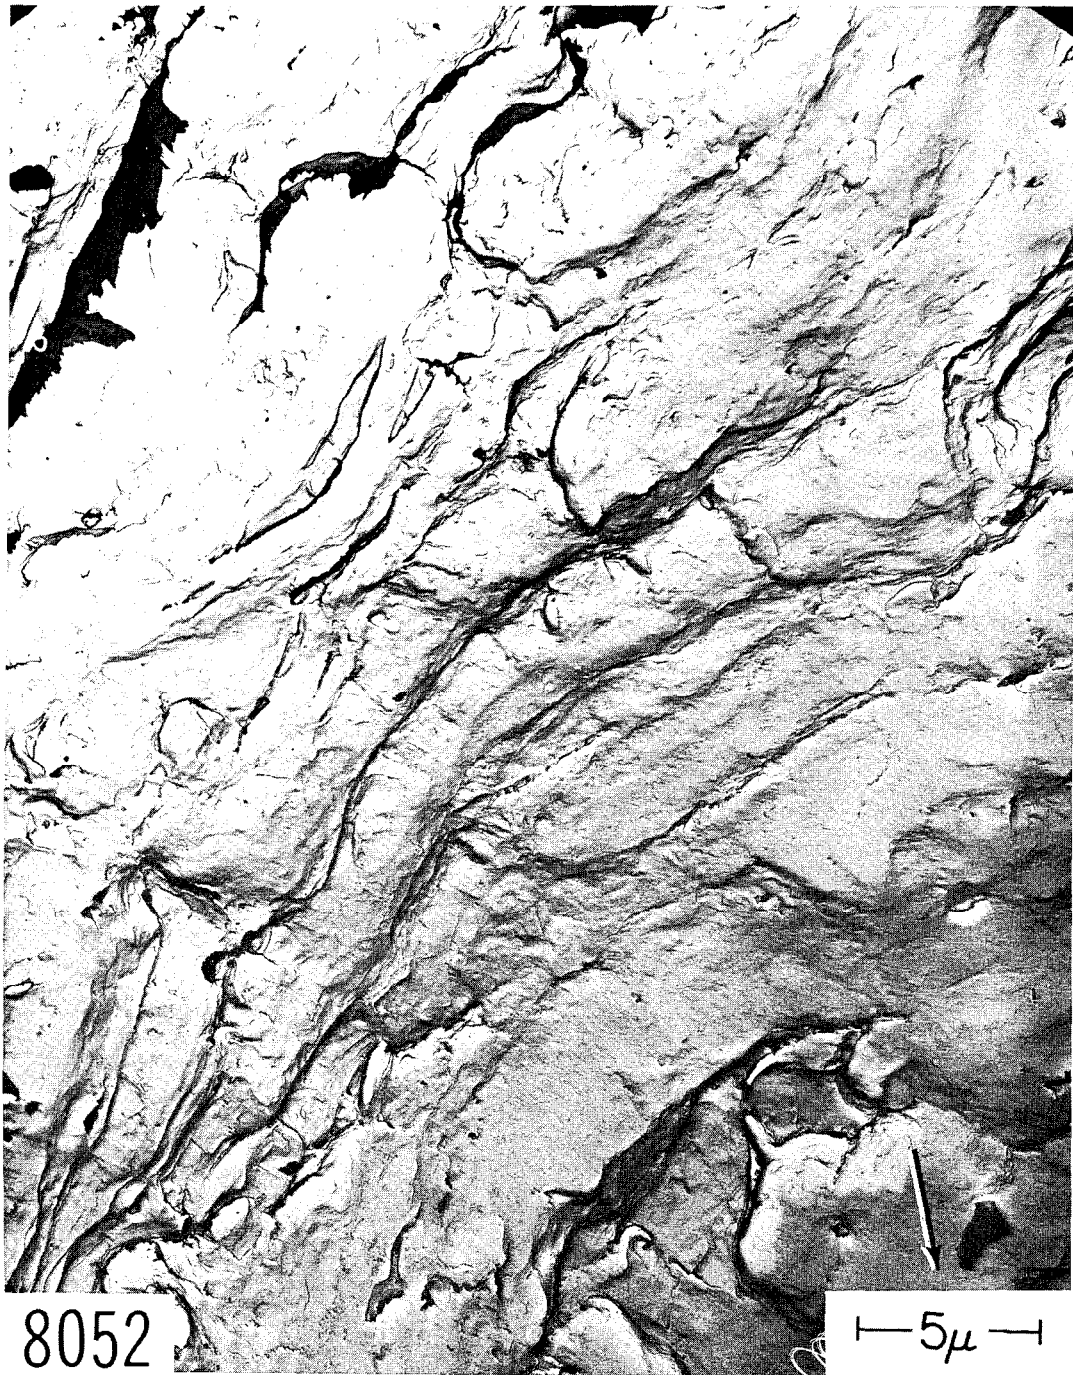
Fig. 92 - Fatigue striations in the fatigue crack shown in the HY 80 specimen in Fig. 90. Cellulose acetate-carbon replication technique. Palladium shadowed. 6000X.

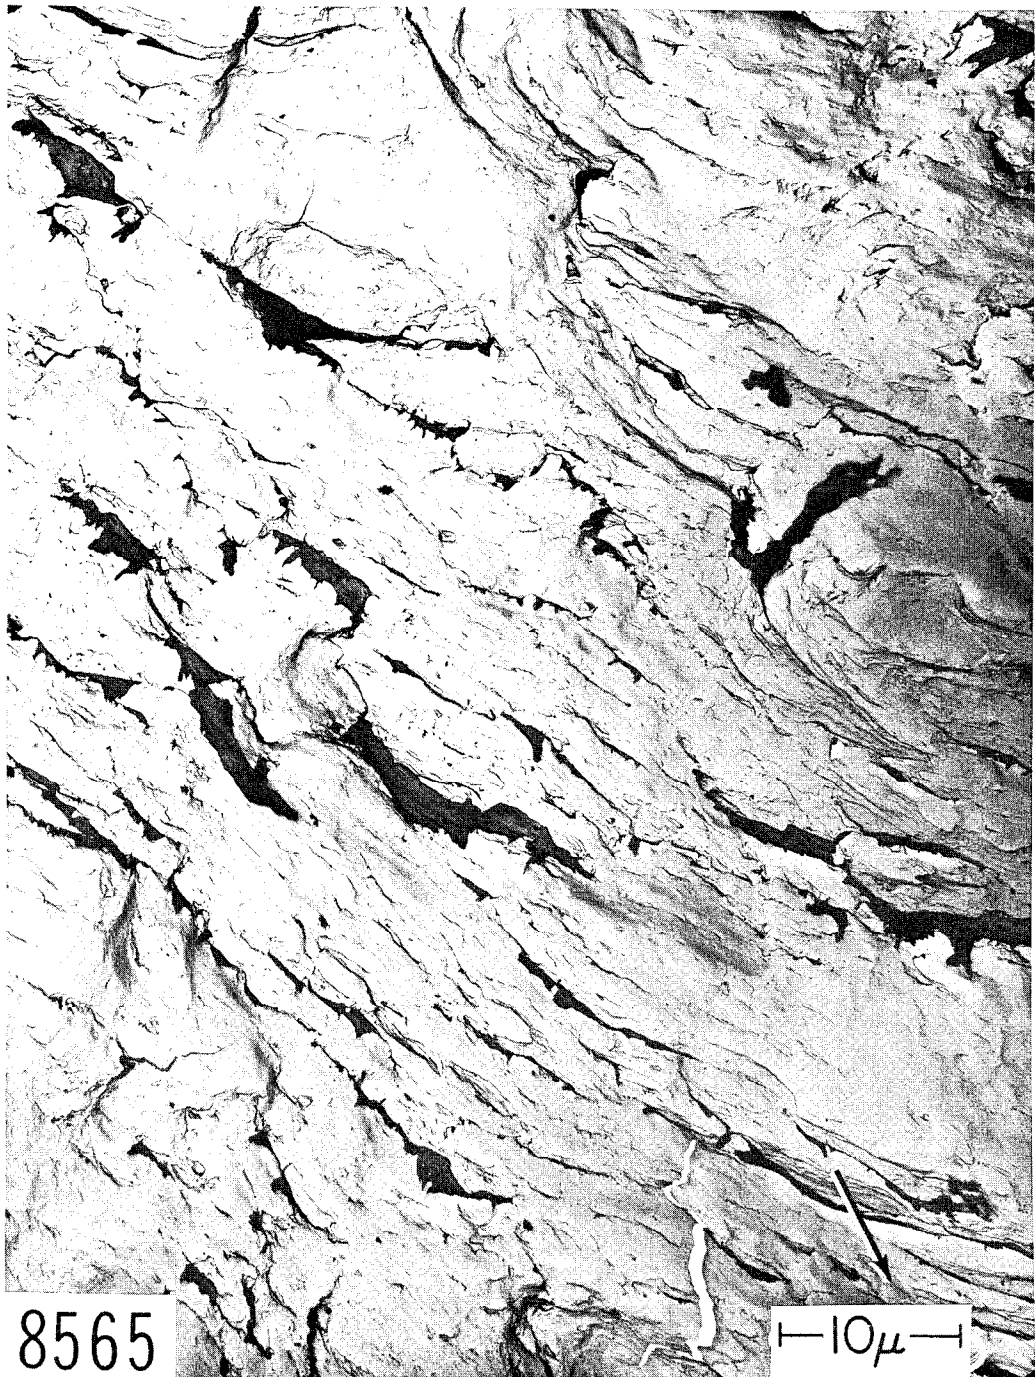
Fig. 96 - Fatigue markings in HY 110 steel. Cellulose acetate-carbon replication technique. Palladium shadowed. 3000X.

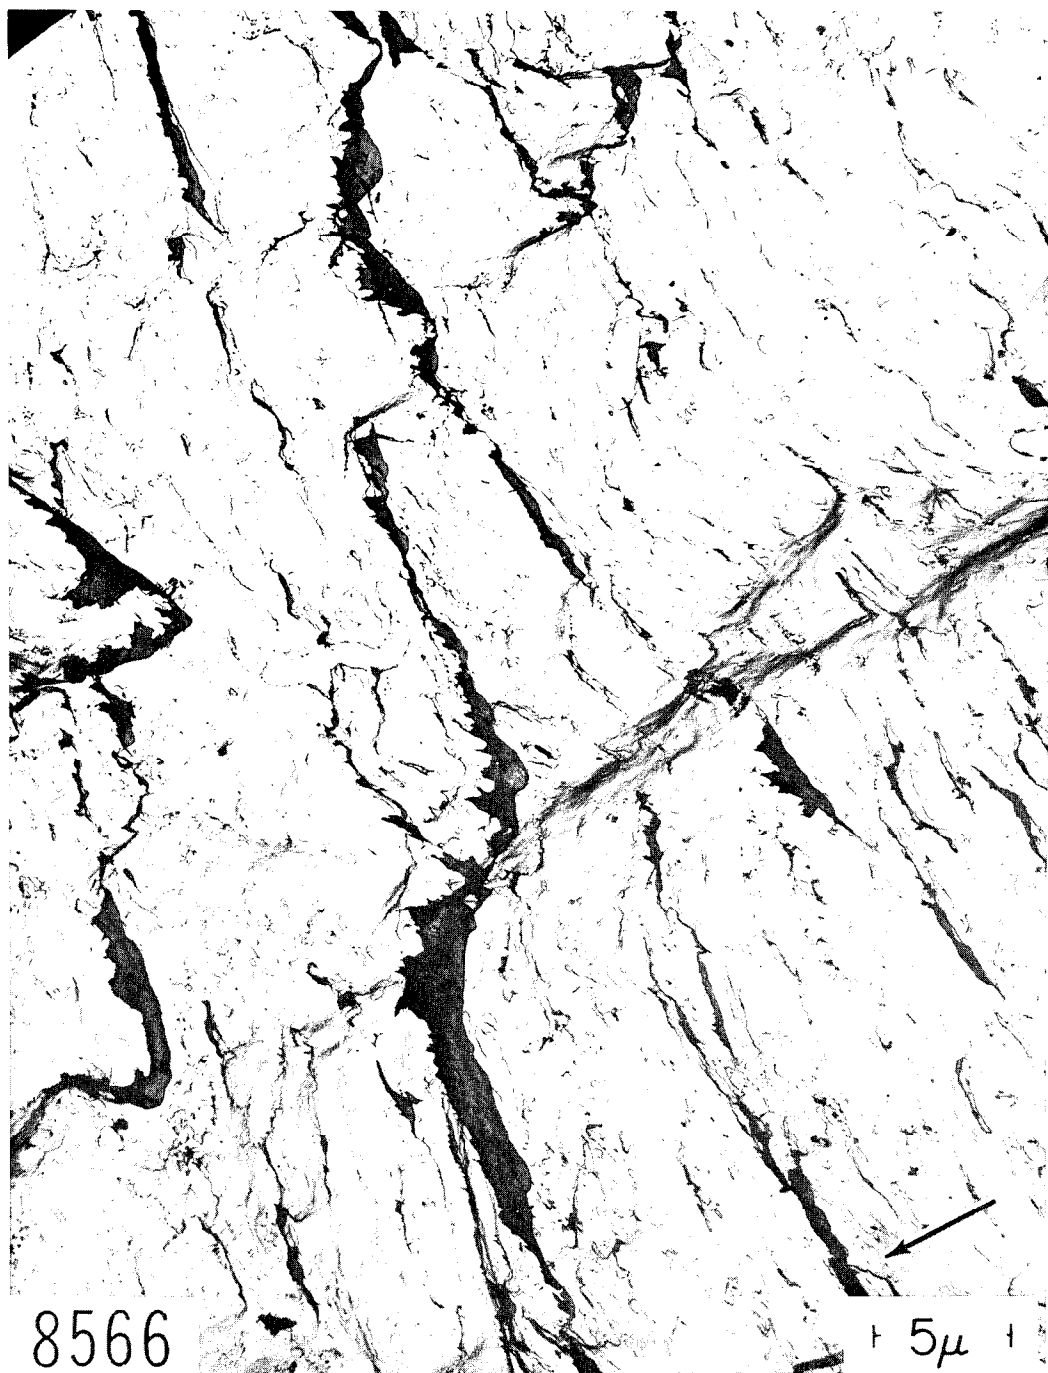
Fig. 97 - Fatigue markings in HY 110 steel. Cellulose acetate-carbon replication technique. Palladium shadowed. 4500X.

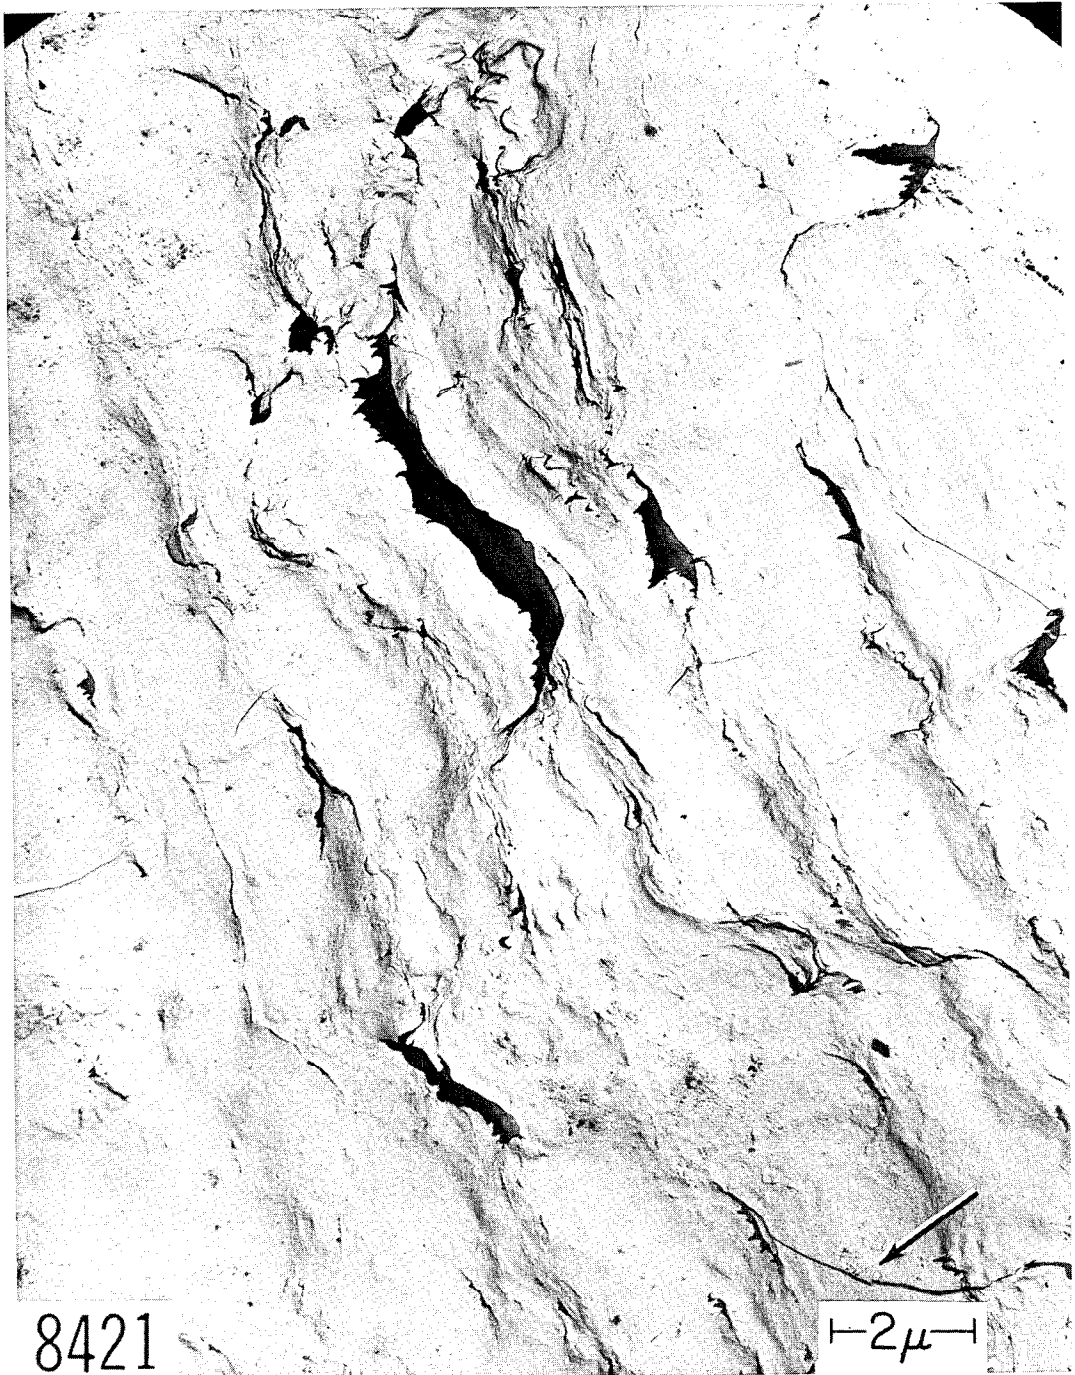
Fig. 102 - Characteristic fatigue markings in HY 150 steel. Cellulose acetate-carbon replication technique. Palladium shadowed. 12,000X.

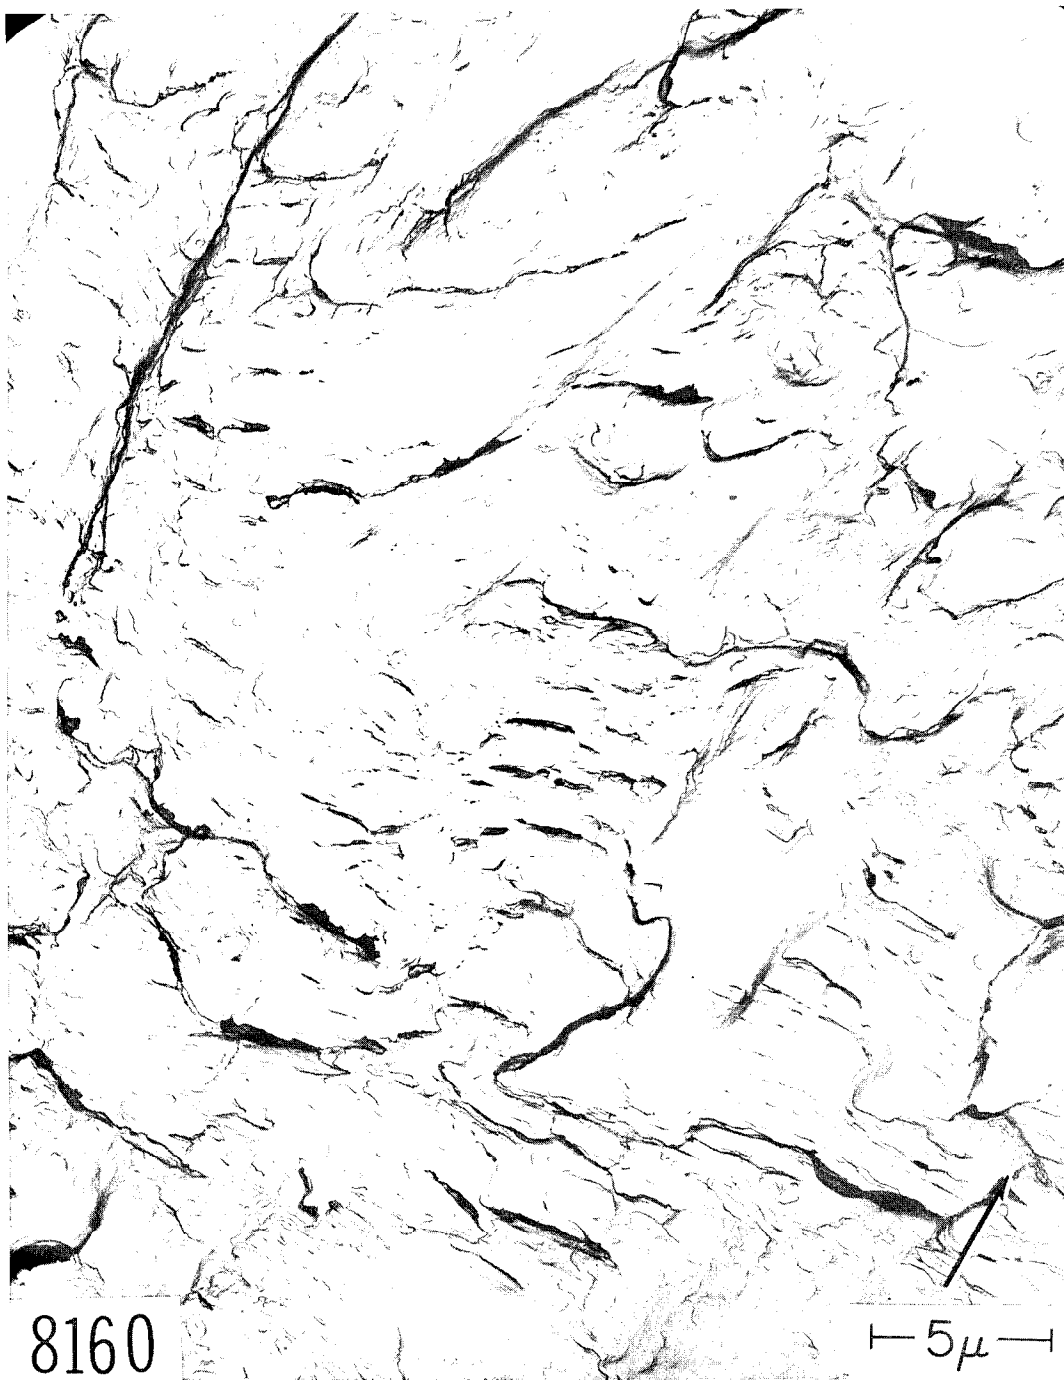
Fig. 113 - Fatigue markings in 250 KSI yield strength maraging steel weld metal. Cellulose acetate-carbon replication technique. Palladium shadowed. 6000X.

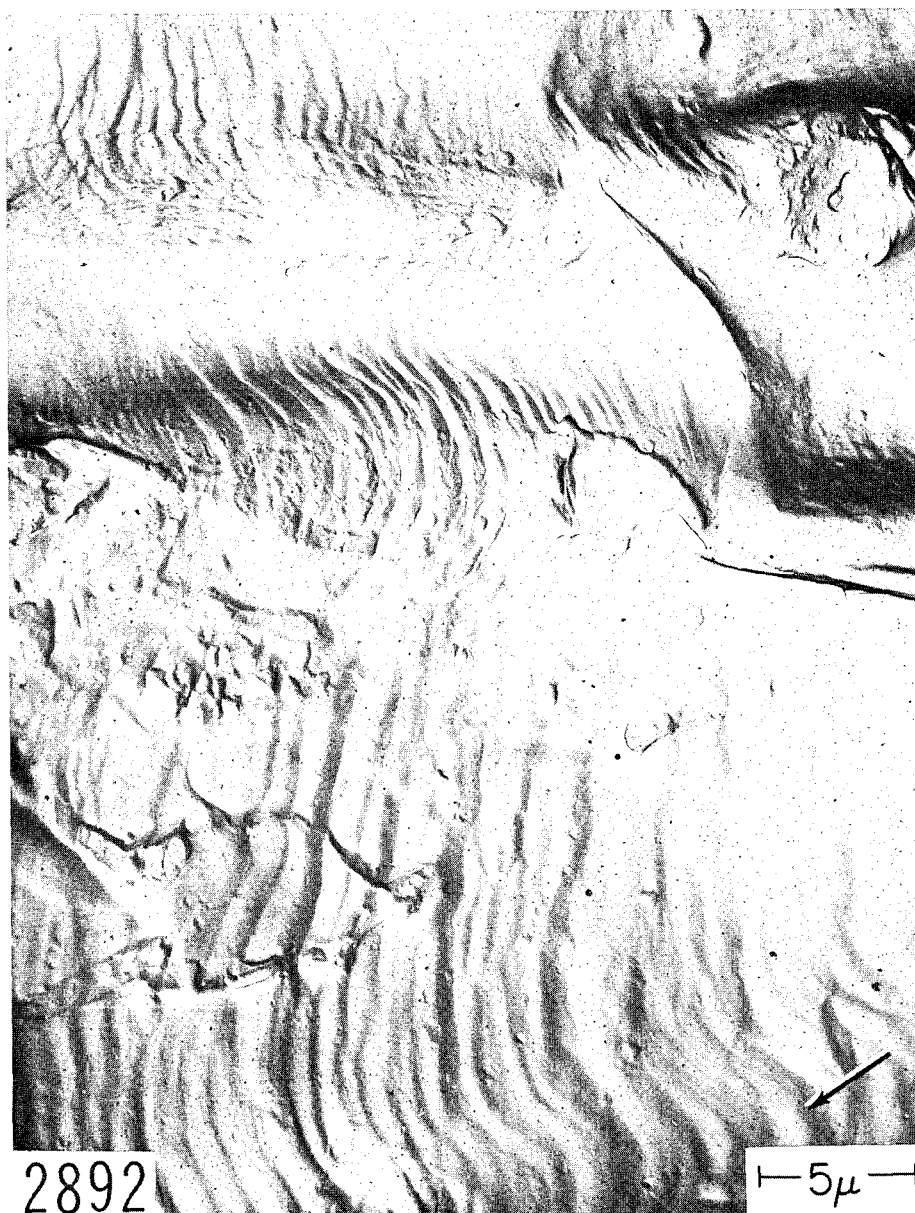
Wallner's lines (8), scraping artifacts (2), and other parallel fracture surface markings arising from factors other than repeated loading are likely to be mistaken for fatigue markings by the novice. Figure 118 shows serpentine glide (4) (i.e., unidentified slip markings forming a plaited pattern) formed when the interfaces between silicate fibers and matrix in wrought iron were plastically deformed in fracture at room temperature. The markings near the top of Fig. 118 in particular might be erroneously identified with fatigue loading conditions.

Fig. 118 - Serpentine glide in wrought iron ferrite matrix. Cellulose acetate-carbon replication technique. Palladium shadowed. 6000X.

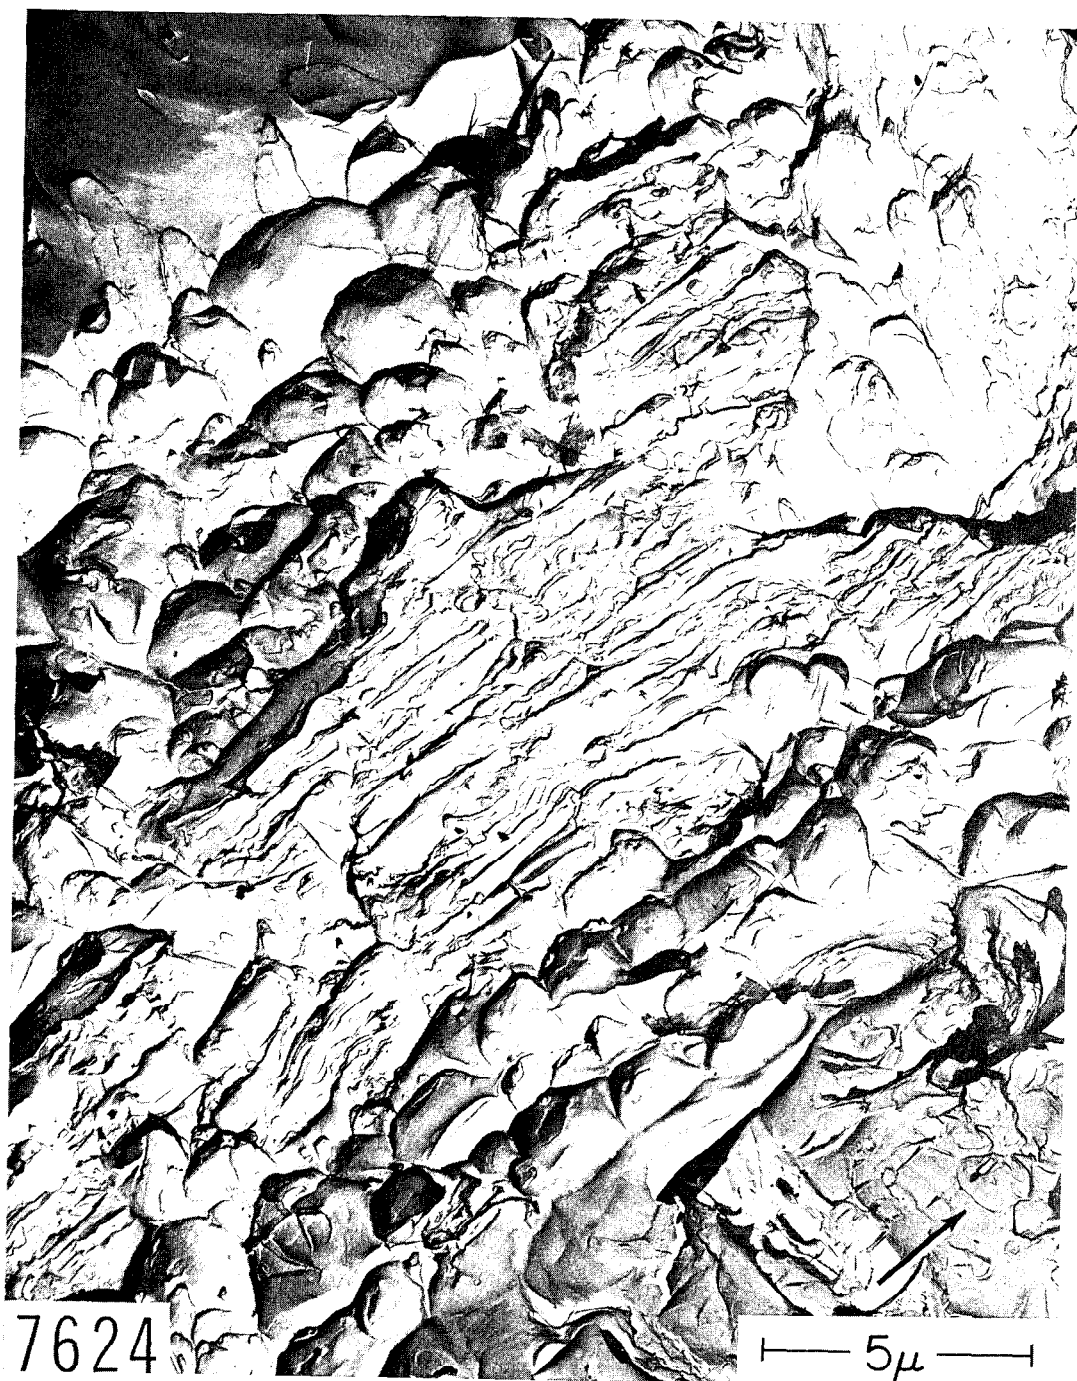
Fig. 120 - Monotonic fracture through eutectic structure in 7075 aluminum alloy. Cellulose acetate-carbon replication technique. Palladium shadowed. 9000X.

Figures 119 and 120 show markings observed in spot-weld metal in a 7075 aluminum alloy. The markings at the top and bottom of Fig. 119 bear a resemblance to fatigue markings but were formed from the cast structure of localized eutectic alloy that was formed when the spot weld solidified. Figure 120 is another example of the same structure. Here the parallel markings are in the middle of the fractograph with their lengths extending diagonally from lower left to upper right.
